**State of Louisiana
Coastal Protection and Restoration Authority**

2017 Annual Inspection Report

Naomi Outfall Management

State Project Number BA-03c
Priority Project List 5

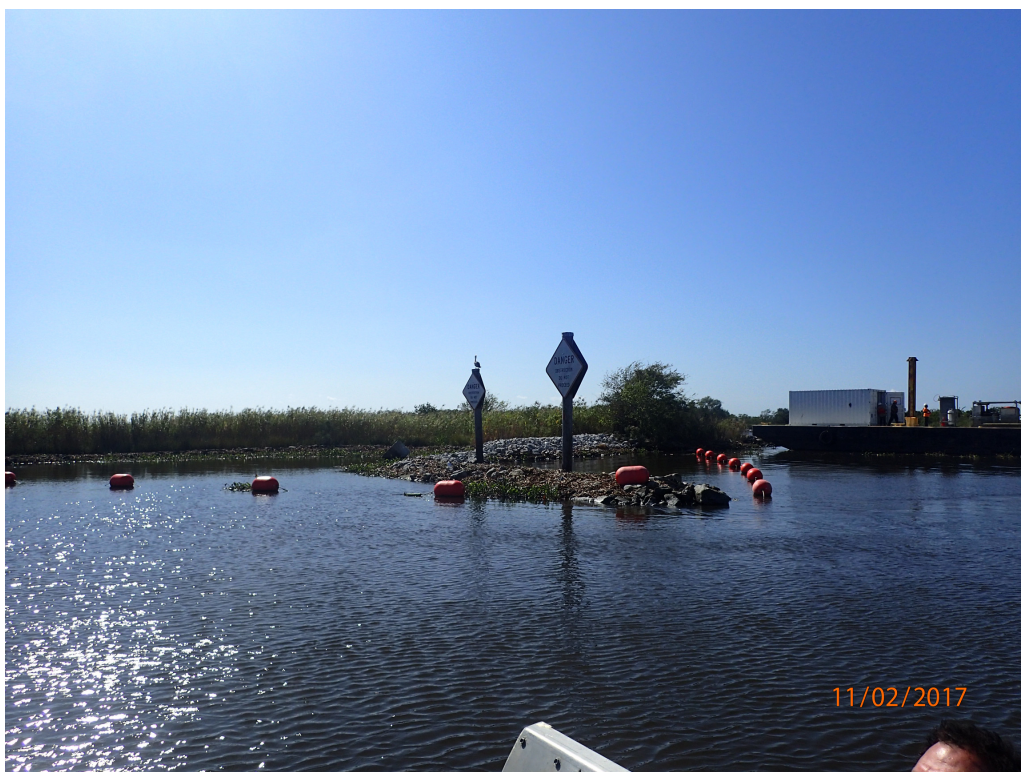
Photo #1 – Rock riprap, warning signs, and buoys (Bayou Dupont)

The rock riprap appeared to be in good condition (Photo #1).

Warning signs appeared to be in good condition (Photo #1).

One of the regulatory marker buoys was missing (Photo #1).

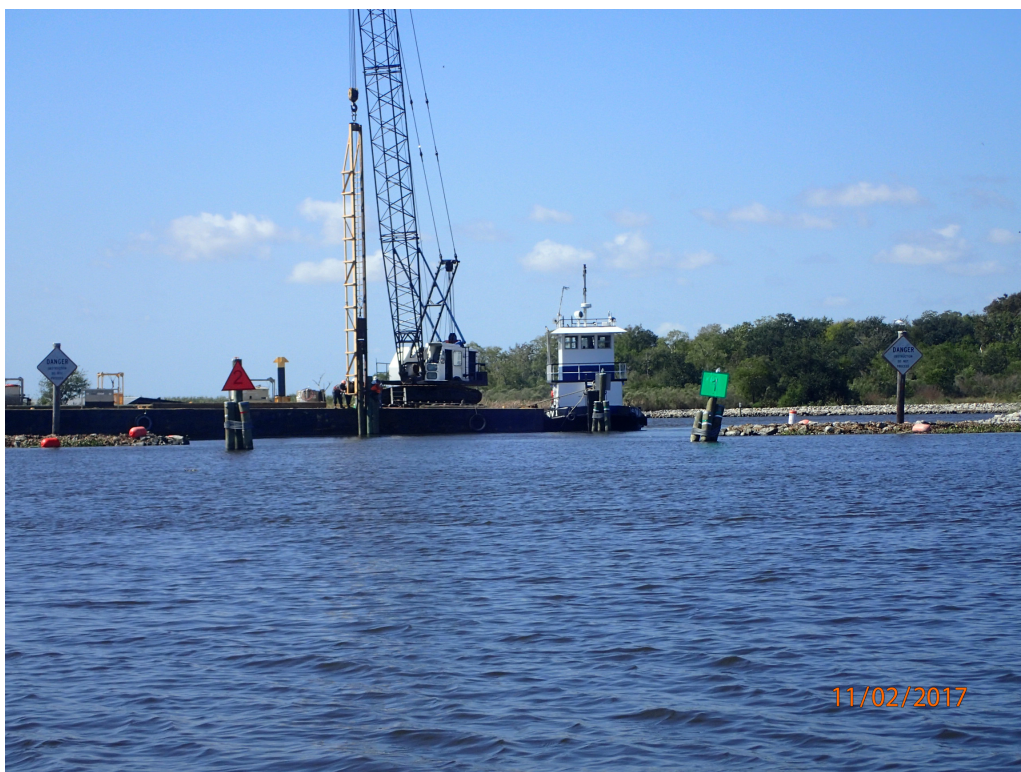
Photo #2 – Pile clusters (Bayou Dupont)

One of the pile clusters was damaged by Frisco Construction and was being repaired at the time of the inspection (Photo #2). Another pile cluster appeared to be damaged and was leaning (Photo #3). The remaining pile clusters appeared to be in good condition.

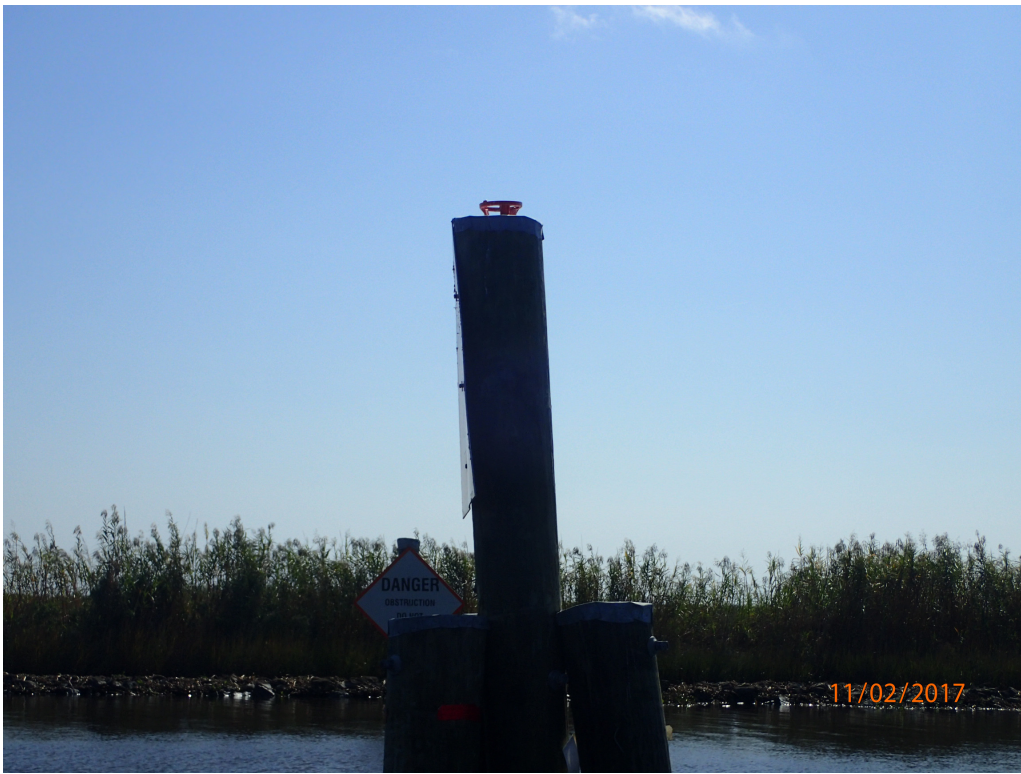
Photo #4 – Missing Navigational Aid Light (Bayou Dupont)

One of the navigation aid lights was missing (Photo #4). Routine navigation light maintenance is performed under a state-wide contract.

- Navigation lights are inspected and maintained under state-wide contract.

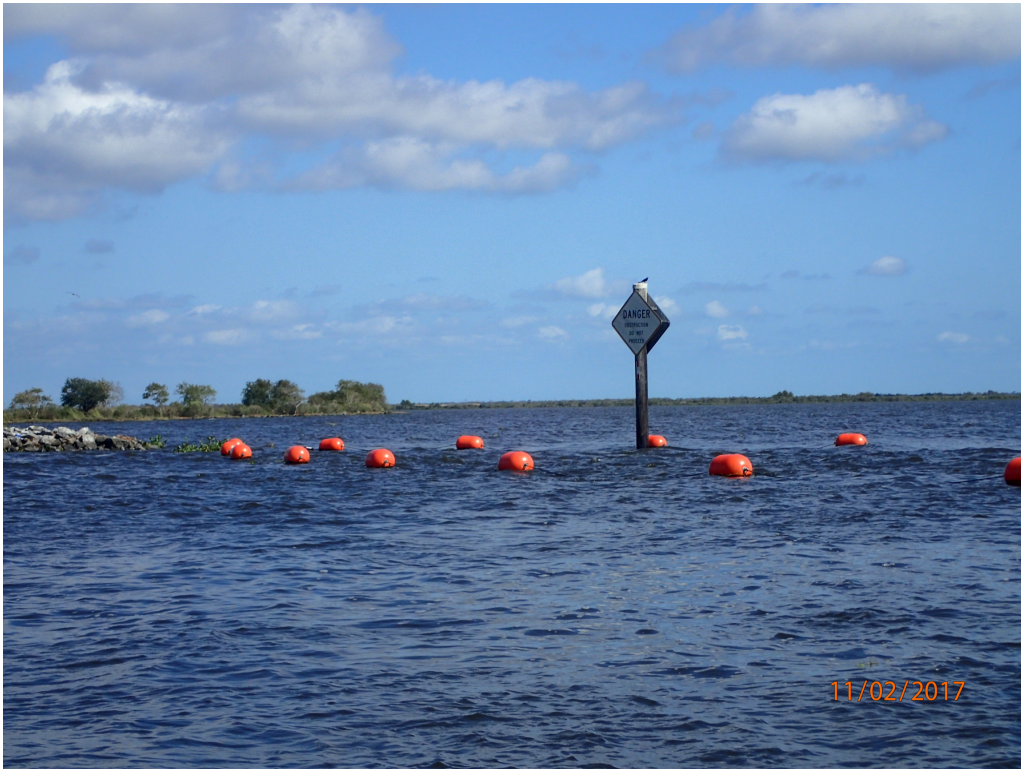
Photo #5 – Rock riprap (Goose Bayou)

The structure has settled an average of 2 feet since construction, resulting in most of the rock being submerged below the water surface (Photo #5). As the weir lies within the footprint of the planned Lafitte Ring Levee, no rock maintenance is anticipated at this time.

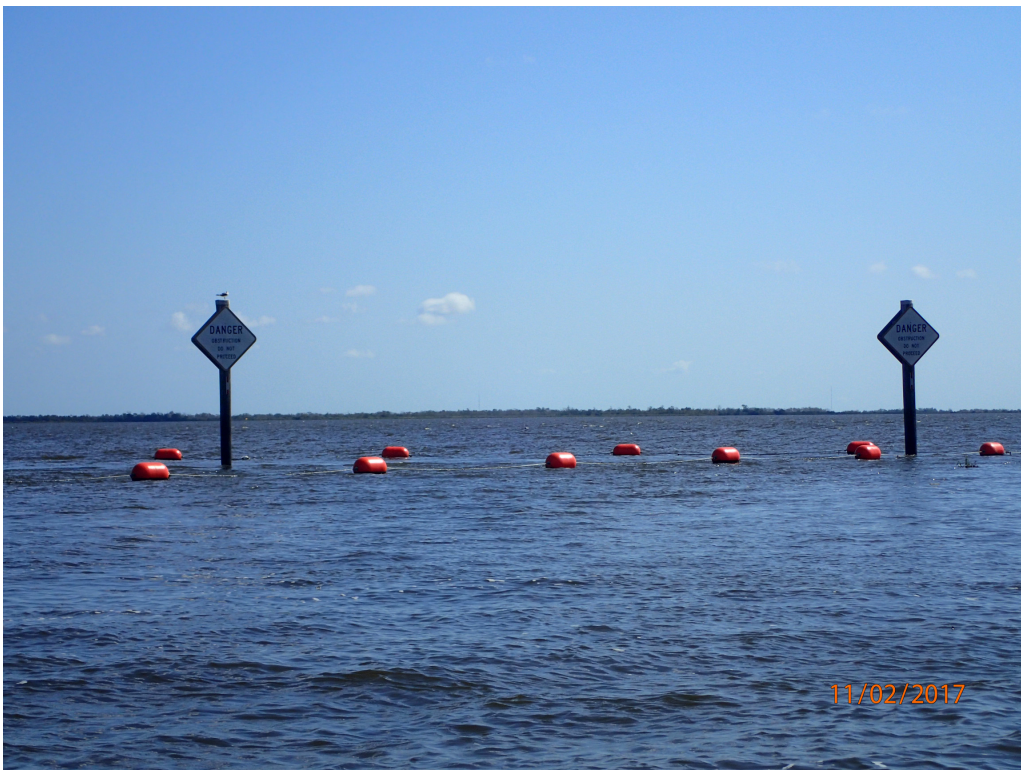
Photo #6 – Piling, warning signs, warning buoys (Goose bayou)

Timber pilings appeared to be in good condition. Reflective tape was replaced as part of the 2015 maintenance event (Photos #6 & #7).

Navigation markers and barrier float cable assemblies were replaced in 2015. Warning signs were in good condition (Photos #6 & #7).

No defects were observed with the navigation aid lights (Photos #6 & #7). Maintenance of these lights is covered under a separate state-wide contract.
